Damage/Needs Assessment

In the Affected Area of
The 2011 off the Pacific Coast of Tohoku
Earthquake and Tsunami

11th of April 2011

SEEDS Asia, OYO International Corporation and Kyoto University

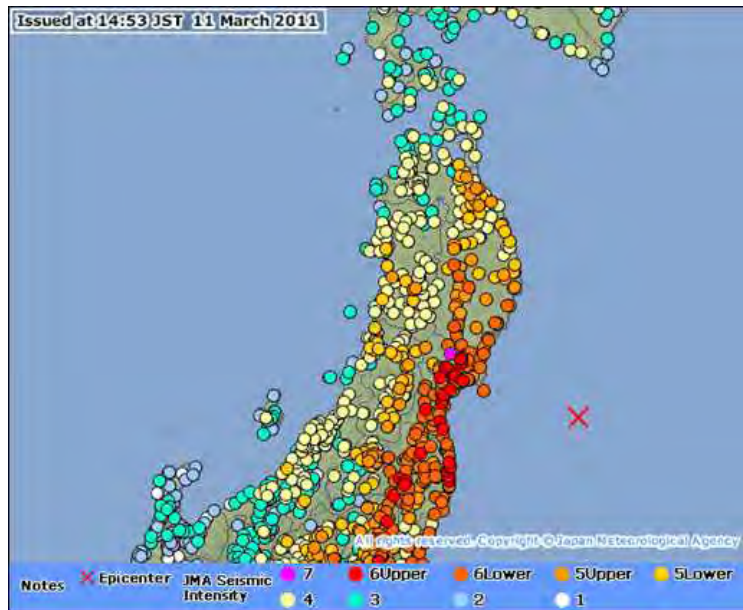
Figure 1. Seismic intensity map for The 2011 off the Pacific coast of Tohoku Earthquake (JMA, 2011)

Table 1 and 2 and Figure 1 are the overview of the earthquake and tsunami provided by JMA (2011).

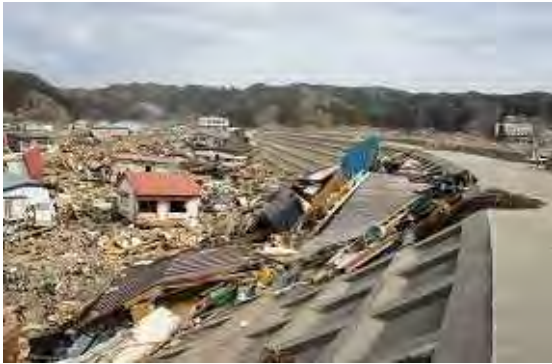
Taro area was damaged by the tsunami caused by Syowa-Sanriku Earthquake, which occurred in 1933. After the event, 10-meater dikes are built to prevent damages by future tsunami. But the area had devastating damages by the tsunami this time. Figure 3 shows the dike and damages. Figure 4 shows the buildings which survived from the tsunami because of the dikes. Most of the houses and buildings are flowed and collapsed by the tsunami. But some buildings are remained. From this result, it was identified that the dikes could not prevent tsunami damages but that they are effective to some extent.

Figure 3. Damages by the tsunami in Taro area

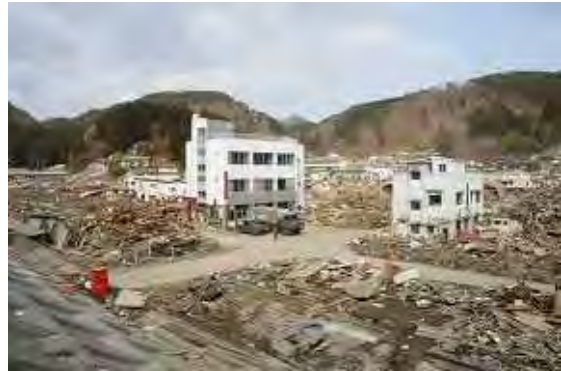
Figure 4. Buildings which survived during the tsunami in Taro area

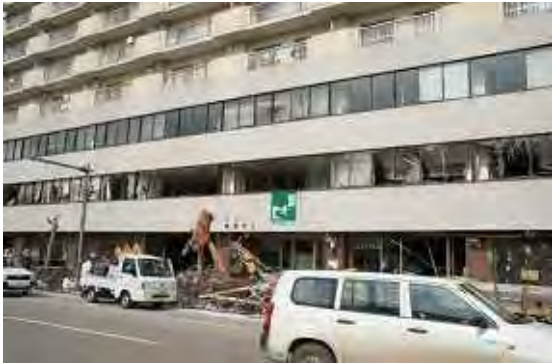
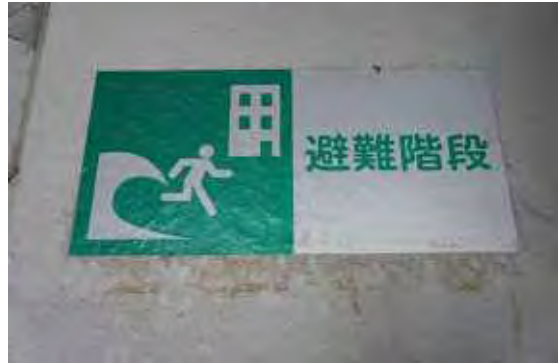
In Kamaishi, there are two tsunami evacuation building officially decided by the local government for evacuation. The survey team visited one of them shown in Figure 7. The number of stories of this building is eight. The first to third floors are used for offices and fourth to eighth floors are residential spaces. There are also road near this building for evacuation in tsunami situation. One of inhabitant told the tsunami came to the third floor of this building. Local residents were evacuated in this building and the road temporarily. In addition, he mentioned they had evacuation training 3rd March. It is expected that the training was effective for local people to re-realize the place for evacuation and how to do in tsunami situation.

Figure 7. Evacuation building [8 storey building with evacuation more than 4th floor]

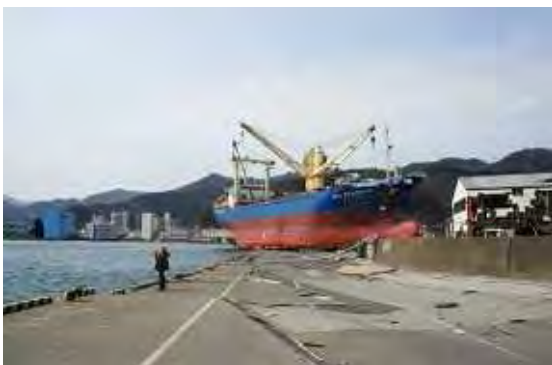
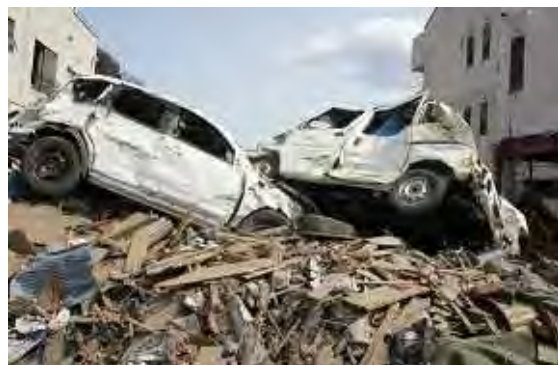
Figure 8. Damages by the tsunami [left: transported ship, and right: destroyed cars]

In addition, he explained the situation after the tsunami. Kamaishi city was severely damaged (refer to Figure 8). Because of the tsunami, communication system like mobile phone and internet were out of order for a week. Therefore, local government could not transfer information to outside area, and other local government or people outside could not know the situation of Kamaishi city. Japan Self-Defense Forces reached to the city one week after.

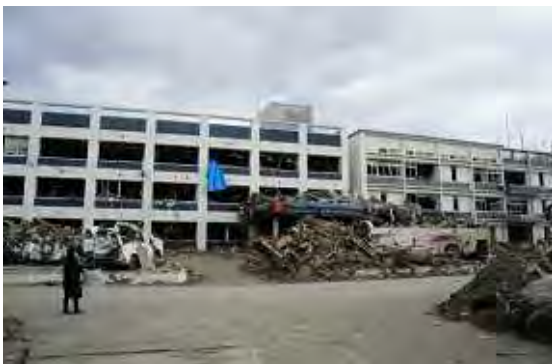
This city was devastated. Figure 11 is the government office building and Figure 12 is the surrounding area of the building. The government office building is damaged and it is possible for the government to work there. It is expected that all of documents, facilities, and equipments were severely damaged. Around the government building, most of houses and building were flowed. It is difficult for local people even to find their own property or belongings.

Figure 11. Damaged local government building

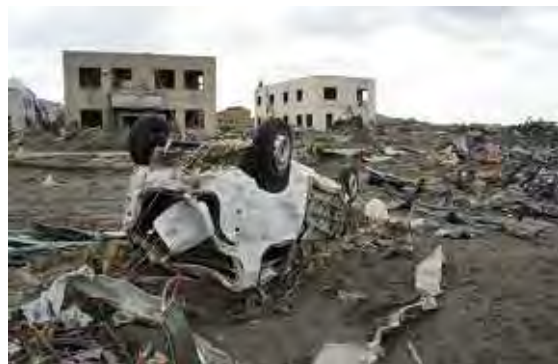
Figure 12. Damages by the tsunami

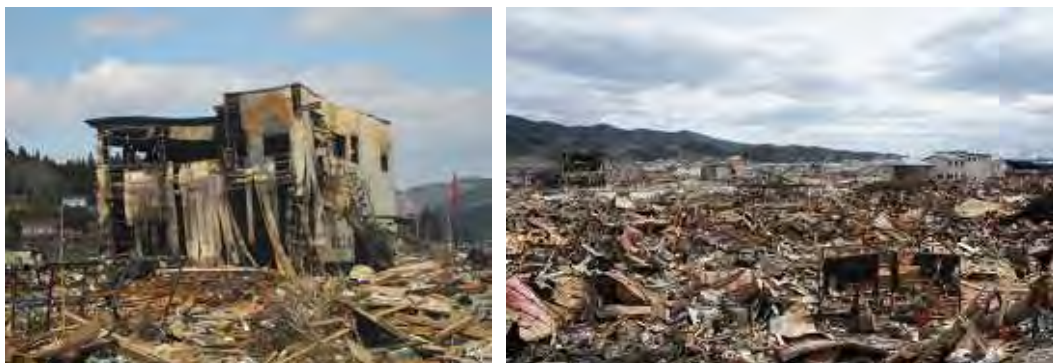
Kesennuma city is severely damaged. In this city, heavy oil was flow out and it was burned. Therefore, many burnt pieces of rubble are seen in the city (refer to Figure 15). The city was devastated. Train could not run in this area because rail tracks are also damaged (refer to Figure 15).

Figure 15. Damages by tsunami and burnt areas

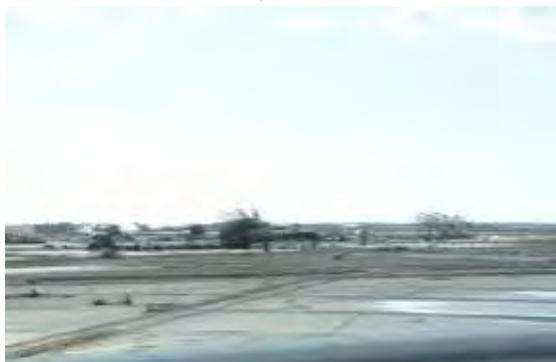
Yamamoto town was heavily damaged by the tsunami because it is located in plane area (refer to Figure 16). But the government building was remained. In the first floor of the building, FM station was established. The roles of the FM station were similar to that of Ofunato city. The person who is in charge of management of FM station is a person who retired from TBC (Tohoku Broadcasting Company). He moved to live in this town after his retiring. Because he was an announcer in TBC and had several connection due to his working history, he and local community could establish FM station. He has similar aims on FM station which the person in Ofunato city has. The FM station invites government persons including the town mayor and asks them to announce the current status and future plan for recovery and reconstruction (refer to Figure 17). As mentioned before, the person who is in charge of the FM station emphasized the radio should be utilized for community development as well as prompt and appropriate recovery and reconstruction. Inviting the government persons is one of challenges to achieve it. Because of this challenge, FM station can make the linkage between local community and the government. He is considering that FM station would be able to be continued for community development if the local government understands the importance of FM station.

Figure 16. Damages by the tsunami

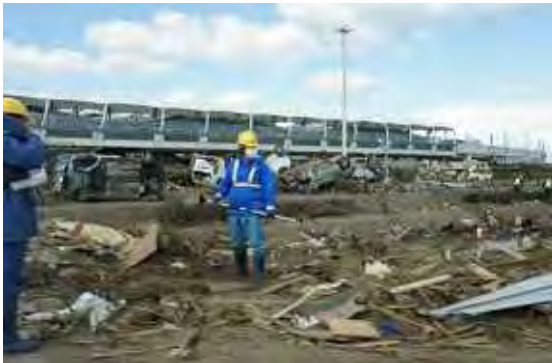
Sendai airport is located in Natori city. The airport is the biggest one in Tohoku area and it is not available because of the disaster (refer to Figure 23). Therefore, relief goods or other necessary things needs to be carried from other airport of Tohoku area or on the road. In the residential area of Natori city, there is the small hill (refer to Figure 24).

Figure 23. Damages around the airport

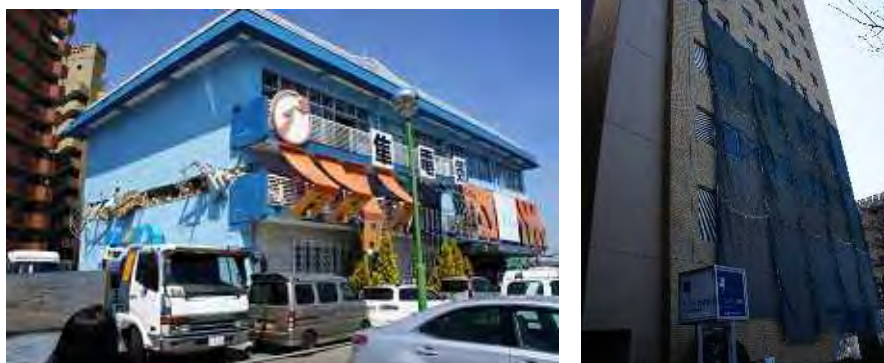
For house, clay tiles on roofs were damaged. Some large scale building in Sendai city had damages on the structure (refer to Figure 27). However, completely destroyed houses or buildings could not be seen in the both prefectures.

Figure 27. Building damaged by the earthquake
